ENGINE HOOD DEFECT ANALYSIS OF MAUNG 4X4: MULTI-LINE OPTIMIZATION STRATEGY AND ITS IMPACT ON PRODUCTION COST AND SCHEDULE – A CASE STUDY AT PT XYZ

Putri Rizqi Oktaviana*, Purnawan Adi Wicaksono

Department of Industrial Engineering, Faculty of Engineering, Diponegoro University
Jl. Prof. Soedharto, SH, Undip Tembalang Campus, Semarang, Indonesia 50275

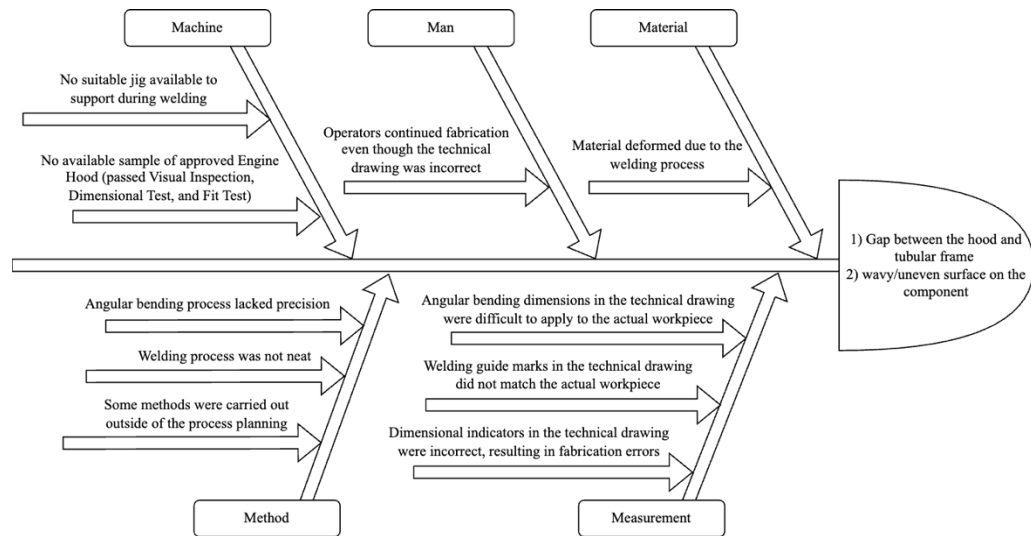
Figure 3.2 Fishbone Diagram of Product Defect Analysis

Analysis of all 81 front engine hood units revealed two consistent defects: gaps between the hood and tubular frame (5-10 mm), and surface waviness (3-8 mm). These defects compromise both function and aesthetics, as noted by Groover (2019). Using a fishbone diagram (Figure 3.2) as recommended by Aljajo and Fisabilillah (2020), we identified multiple root causes across five categories:

Machine-related factors included inadequate welding jigs, which led to component deformation, and the absence of approved reference samples. Human factors involved continuing fabrication despite known errors in technical drawings, compounded by weak coordination between design and production teams (Daniarsyah, 2021). Material issues stemmed from the 1.5 mm ST 37 steel's tendency to deform under welding heat (Sukarman, 2019). Methodological challenges were observed in achieving precise angular bends and maintaining consistent welding techniques (Sulistiono, 2021). Measurement errors arose from mismatches between technical specifications and actual manufacturing capabilities, compromising product quality (Gaspersz, 2004).

Among these, the absence of proper welding jigs was identified as the most critical root cause. Without adequate stabilization during welding, thermal stresses caused misalignment and surface irregularities—manifesting as gaps and waviness on the product. To mitigate these issues, this study recommends developing custom welding jigs, establishing approved reference samples, strengthening communication between design and production teams, implementing standardized welding procedures (Huda & Taufiqurrahman, 2022), formalizing fabrication methods, and introducing collaborative verification of technical drawings. These interventions would likely reduce defect rates, improve process efficiency, and eliminate substantial repair costs in future production (Riyanto, 2015).
